Model	Model Code	Year Model
ACCORD 4D	CU3	09, 10, 11
ACCORD TOURER	CW3	09, 10, 11

Issue Date
09-10-13

DPF Warning Light Comes On

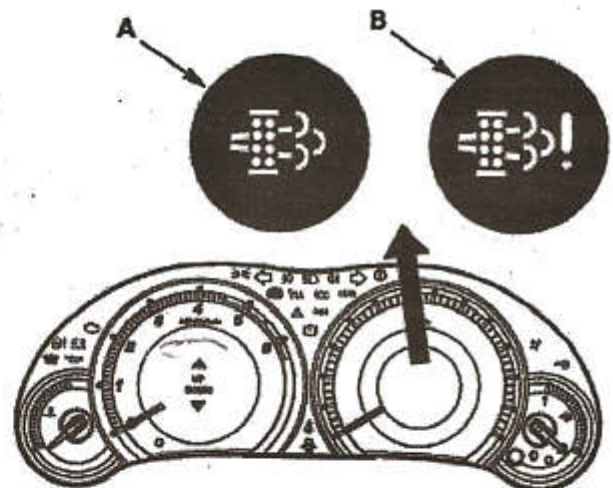
- When the CHECK SYSTEM (DPF OVER ACCUMULATION)MIL light (B) is on.
- Note: A Service Regeneration is not required for light (A): "DPF Regeneration Required". In this case, inform the customer to drive their vehicle to conditions stated in the owners manual to regenerate the DPF system.

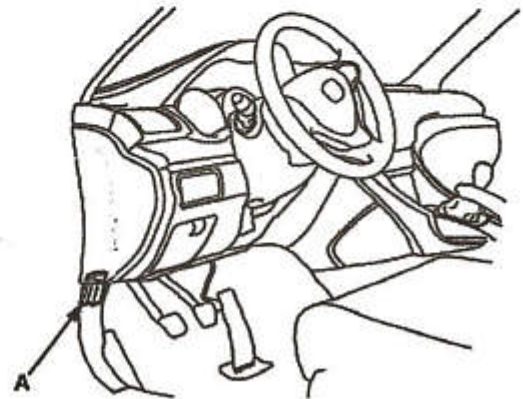
1. Check the engine oil level. If the level is +20 mm (0.79 in.) above the upper level mark, replace the engine oil.
2. Turn the ignition switch to ON (II).
3. Connect the HDS to the data link connector (DLC) (A) located under the driver's side of dashboard.

*: This illustration shows Left Hand Drive model. Right Hand Drive is similar.
